# Manhole Inspection Summary

Manhole # S41GG\_030MH

Insp Date: **7/18/08 2:52 PM**

**Location** Address: **1241 CENTRAL AVE**

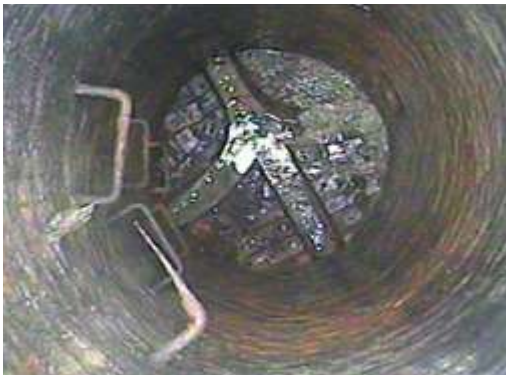
Defect 6

Condition: ☐ Sound ☐ Cracked ☐ Root Intrusion ☒ **Deteriorated** ☐ Leaks ☒ **Debris**

deteriorated channel and debris

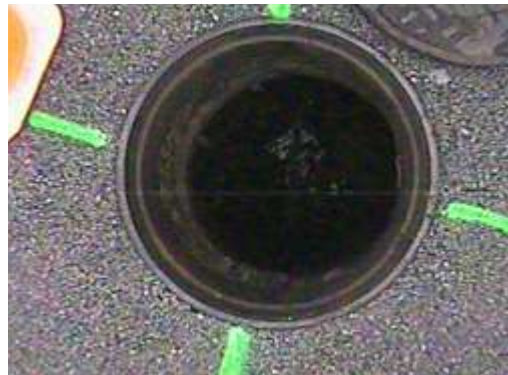
Defect 6

Offset: **2** (in.)

frame offset

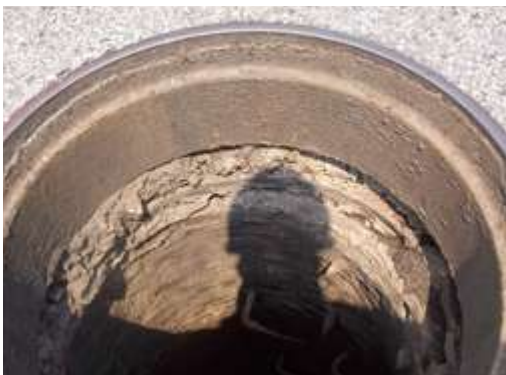
Defect 4

Count: **5** Missing: **2** ☒ **Corroded**

corroded steps

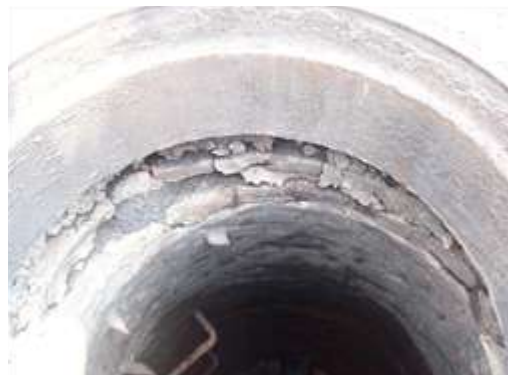
Defect 3

Condition: ☐ Sound ☒ **Cracked** ☐ Root Intrusion ☒ **Loose Brick** ☒ **Deteriorated**

chimney loose bricks and deteriorated

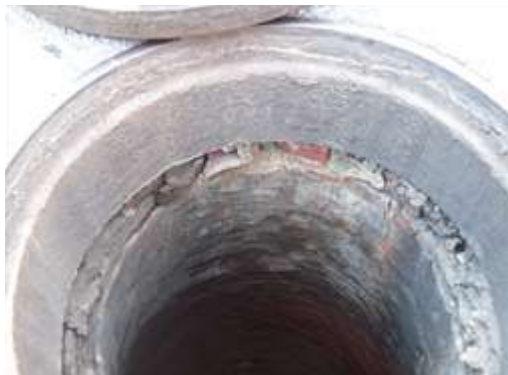
### Defect 2

cracked chimney

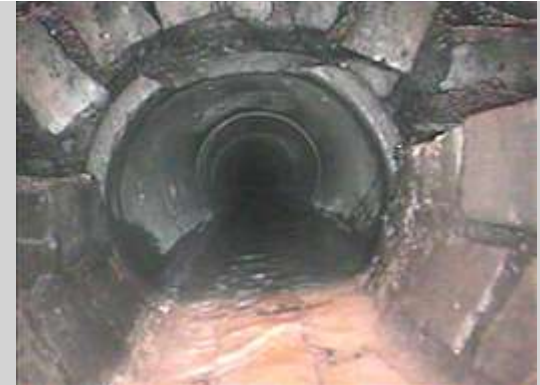
12 O'Clock Outflow

Pipe Height: (in.) Direct  
Pipe Material: **Clay** ☐ Pipe Lined  
Invert Depth: **11.52** (ft.) Flow Characteristics: **Slow**  
Deposits: ☒ None ☐ Mud ☐ Sludge ☐ Debris ☐ Grease  
Silt Depth: (in.) Deposits Extent:  
Infiltration: **None** Pipe Seal Cond: **Broken**

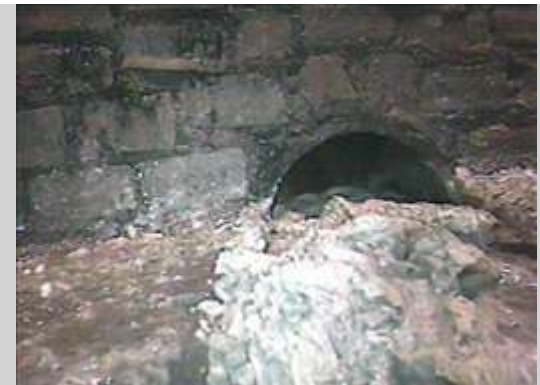
3 O'Clock Inflow

Pipe Height: (in.) Direct  
Pipe Material: **Clay** ☐ Pipe Lined  
Invert Depth: **9.70** (ft.) Flow Characteristics: **Slow**  
Deposits: ☐ None ☐ Mud ☒ Sludge ☒ Debris ☐ Grease  
Silt Depth: **6** (in.) Deposits Extent: **Heavy**  
Infiltration: **None** Pipe Seal Cond: **Sound**

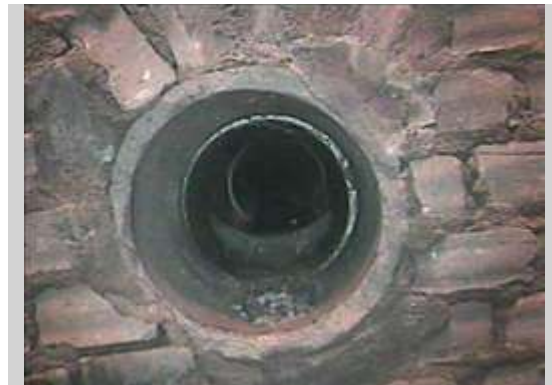
Drop In @ 3 O'Clock

Drop: **Outside Direct**  
Angled: Reading: (ft.)  
Inv Depth: **11.40** (ft.)  
Drop Condition: **Clogged**

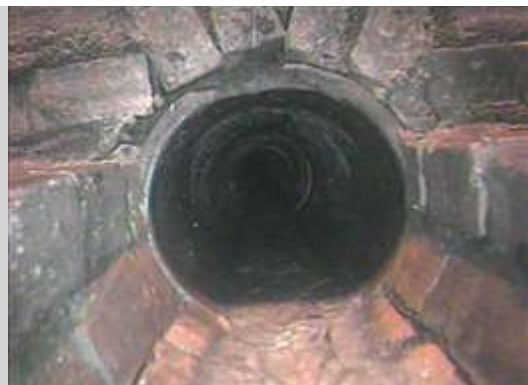
6 O'Clock Inflow

Infiltration: **None** Pipe Seal Cond: **Broken**
